Survey Report

09.07.2025 – 10.07.2025

Yet Marina Göcek / Muğla

Admiral 27

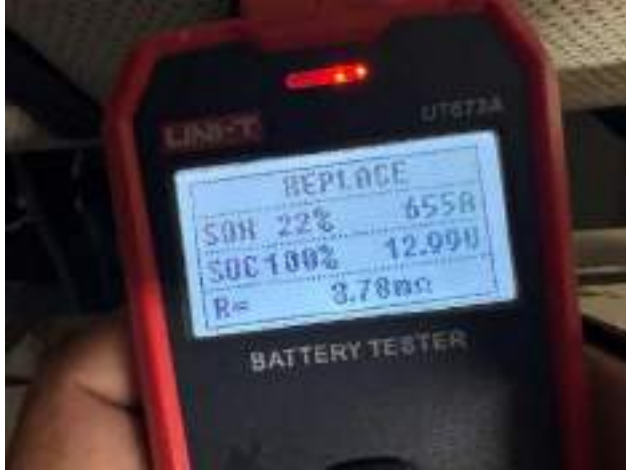
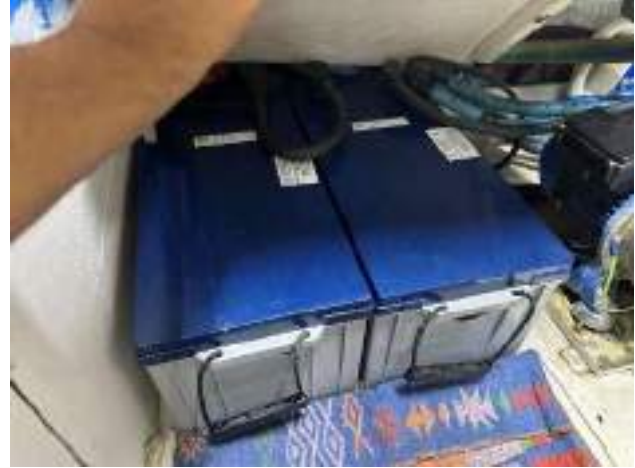
You can check the condition of the batteries from the table. As seen that all the batteries were in poor condition. Engine and generator batteries must be changed.

13 Engine batteries must immediately be changed. Their SOH level was %22 and the batteries had battery liquid under them. The charging voltage was about 12.6V and when it stopped charging, the voltage level was about 11.8V. The battery capacity is finished.

12 Engine battery type was deep/cycle. This is not proper for engine batteries. Deep cycle batteries are used for service batteries.

16 The engine didn't charge the service and engine batteries. Also the generator is in open and Victron is on mode, the service voltage was about 23V during sea-trial. This is very important.

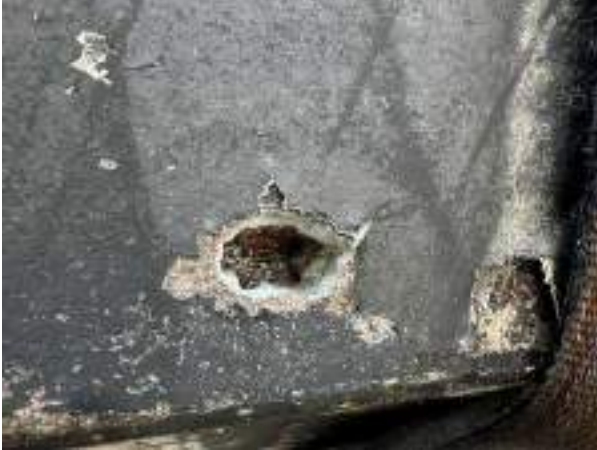
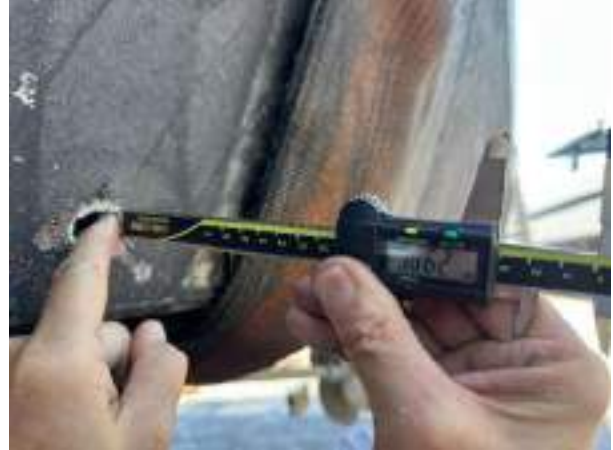
Too tick filler was detached underwater of the hull. Bow side of the boat, the tickness of the filler was about 15mm, starboard aft side 30mm tick of filler was determined. This levels are too high for the normal operations. Normaly for surface flatten, five milimeter filler can be used.

Many areas tick fillers had cracks and start removing from the aluminium hull. This size of filler couldn't stay longer on the aluminium hull.

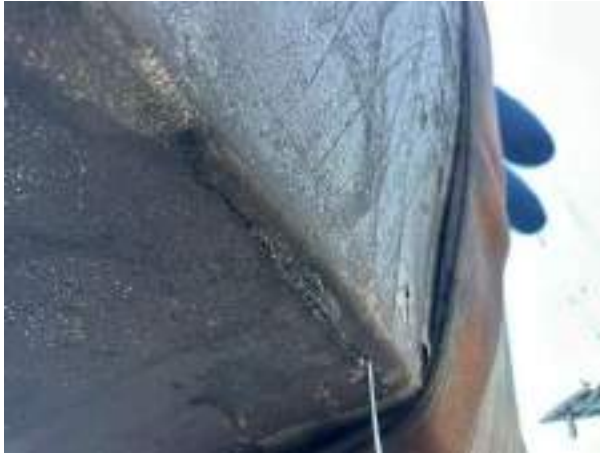
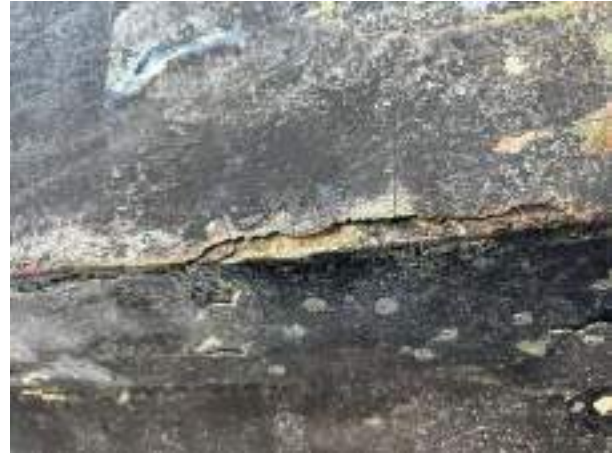
The hull's aluminium tickness was measured with different points. This size of hull, underwater hull's aluminium tickness must be minumum 8mm to 10mm tickness. But during our measurements, we took 5.3mm tickness in some points. These measurements were not safe for the hull. If we accept the minumum amount of 8mm aluminium tickness and the safe ratiom must be minumum 6.4mm tickness. Below this point, the safety will be a risk. Boat industry's comment for aluminium boats, %20 of corrosion of hull, will be risk for the sea conditions. For this boat's hull, below the 6.4mm tickness levels was risk for the hull structural part.

1	Port side of aluminyum tickness was calculated 5.5mm. This is too thin for this size of a boat. 40 feet aluminium sailboats was about 5 mm tickness on their underwater hull.
2	Port side of the hull, 30mm filler was noticed. The reason soudln't be understoid but this filler tickness level was too high than the normal filler standards.

19	Thick filler was applied used underwater of the hull. The tickness of filler was about 30mm in some places.
----	---

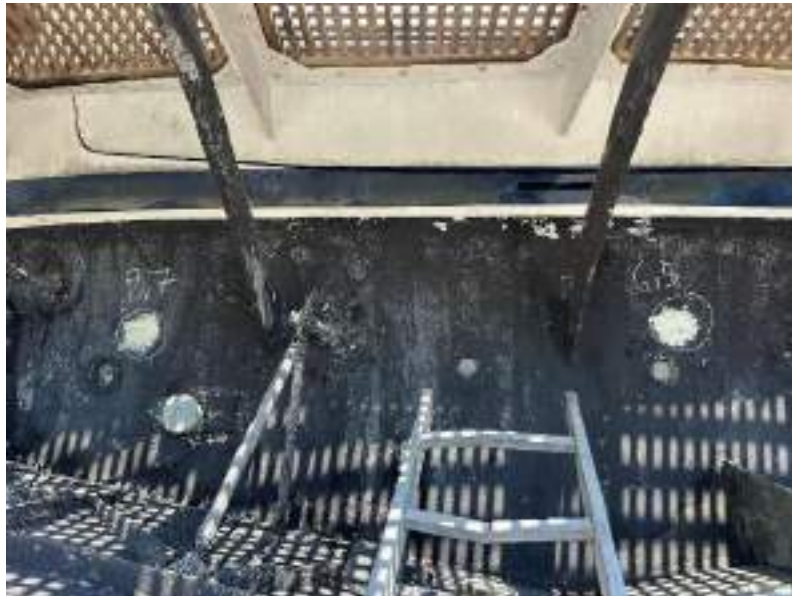
As you check the below photo, the same aluminium panel of the aft side of the boat, starboard side was 6.5mm, port side was 8.7mm tickness.

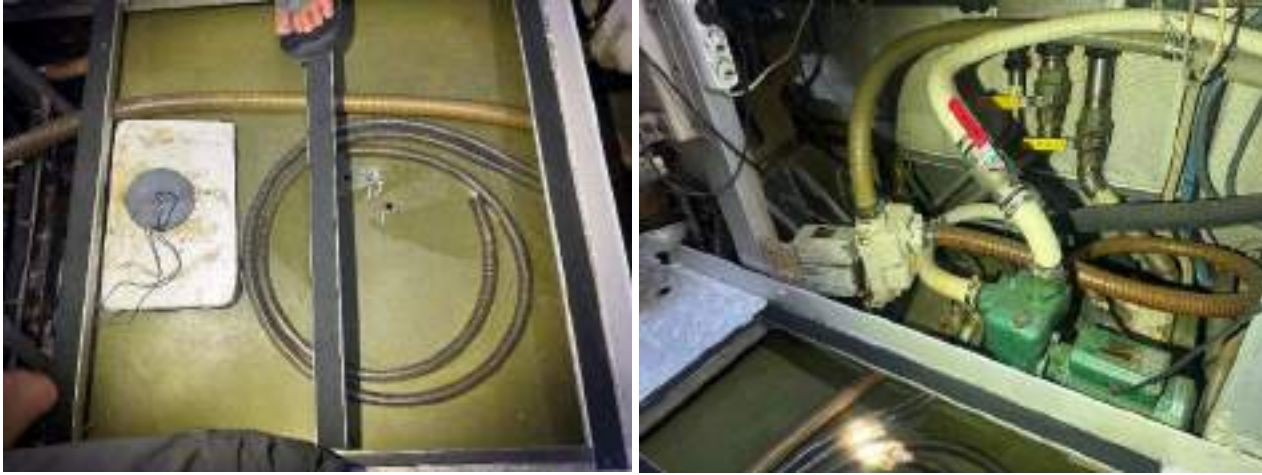
9

Black water tank was not original. It had two holes on the tank. The production metarial of tank was not safe. These tanks couldn't pass the pressure tests.

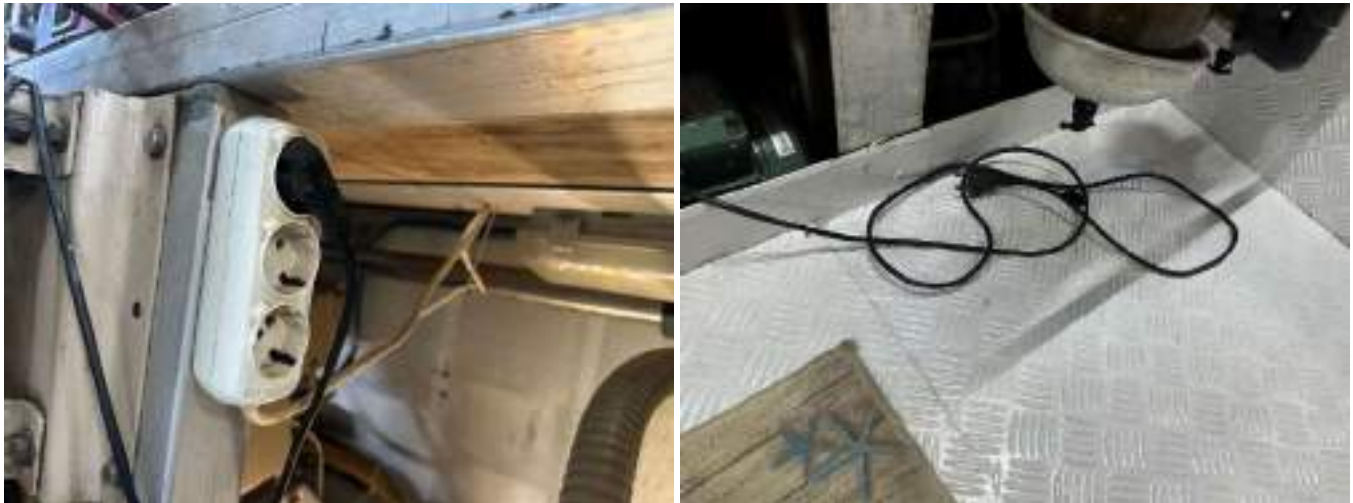
8

Black water was giving out with two 220V electric pumps, they were not safe. You had to put the 220V electric socket on engine room.

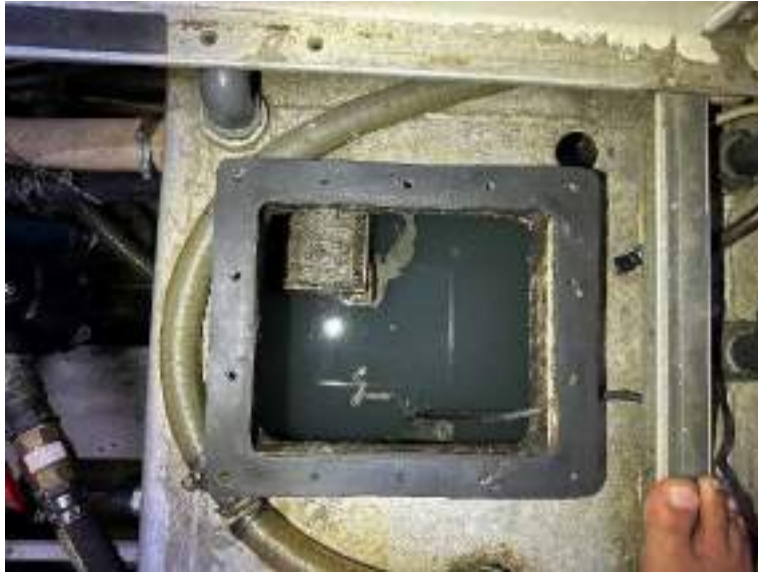
23 Grey water tank that was located between the engines. There was not cover on it. It can easily overflow.

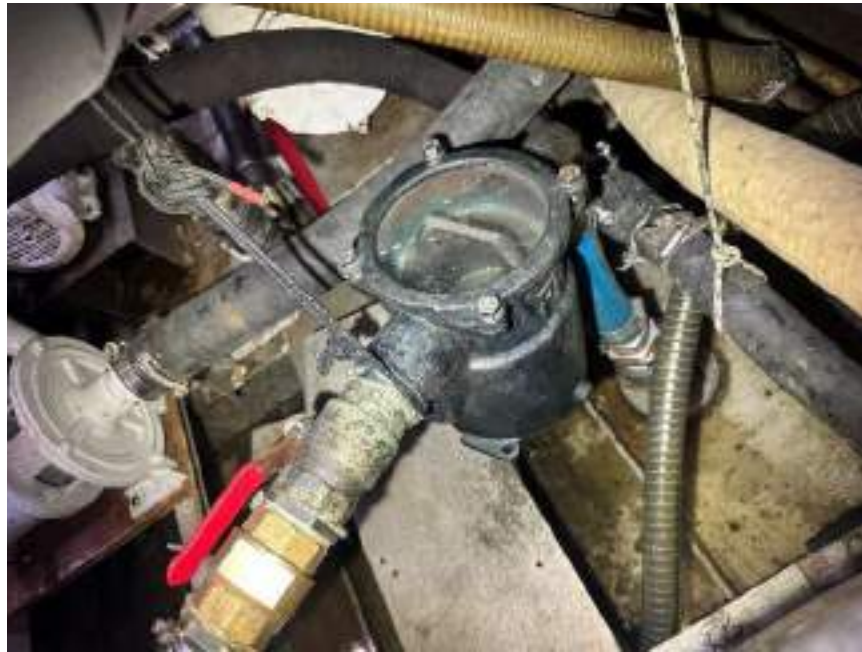
31 The air condition's sea water inlet filter was tied with rope and it had one metal clamp, many different flexible pipes connected. This was not safe.

37 Air condition circulation pump was working with high temperature and it smelled bad in engine room. The working temperature was more than 70C. This just be checked.

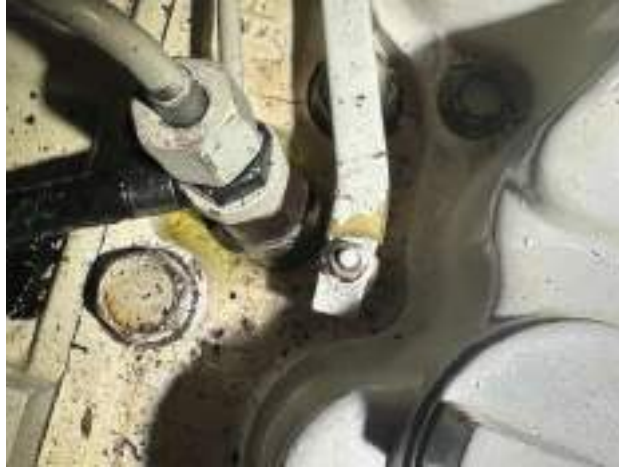
36

Starboard generator had white smoke while working. Sea water cooling system had problem.

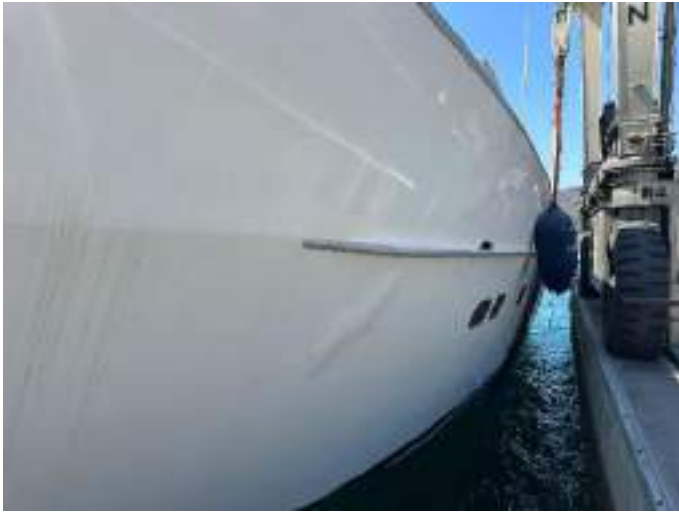
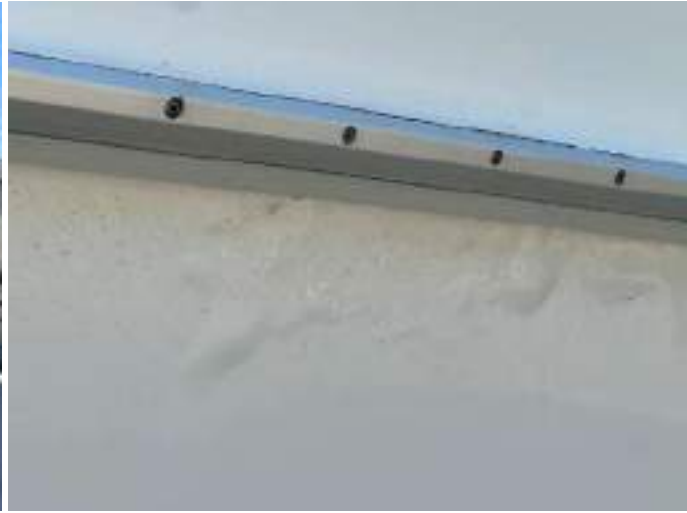
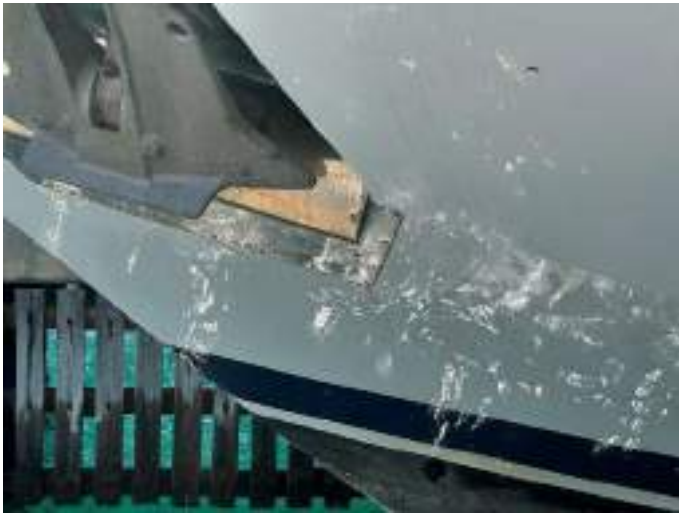
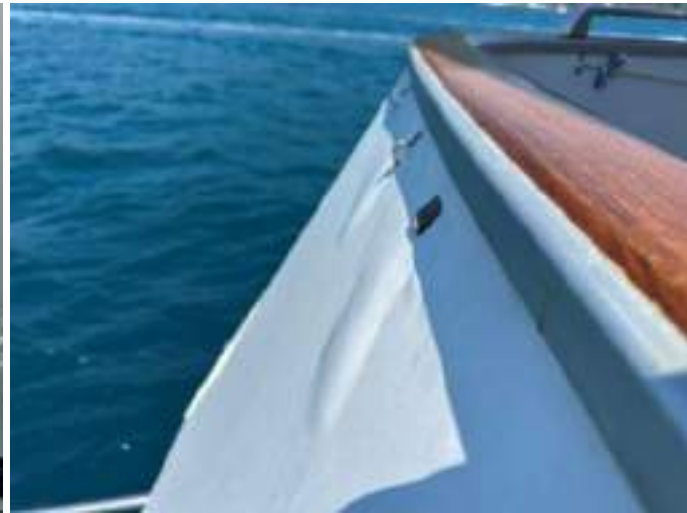
18

The boat was painted with white paint. The hull of the boat had paint delaminated surfaces. Starboard, port and stern side of the hull had paint problems. The problem was caused by the lower surface because of this, the lower base surface must be repaired. For this reason side of the hull of the boats must be painted.

Paint problems were seen on the starboardside of boat. It was a 30cmx50cm area and 20cm x 30cm area.

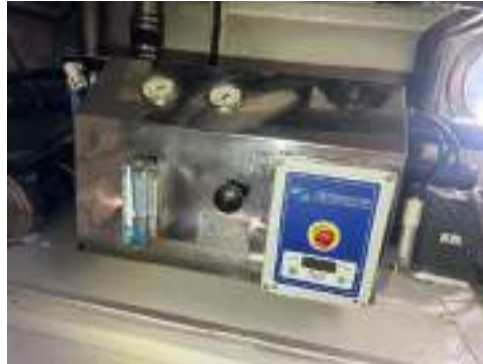
53 Watermaker had water leak on its pressure carbon membran.

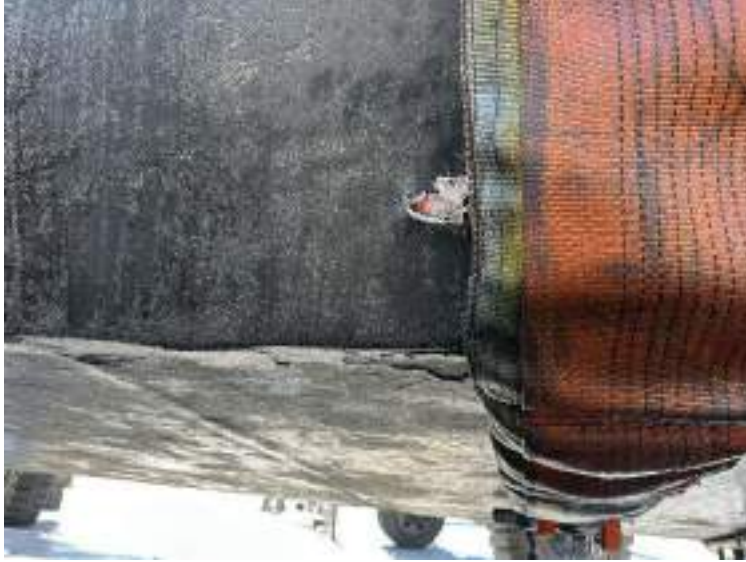
20 There was a repairment on the hull of port side of the sling place. The surface was wavy also.

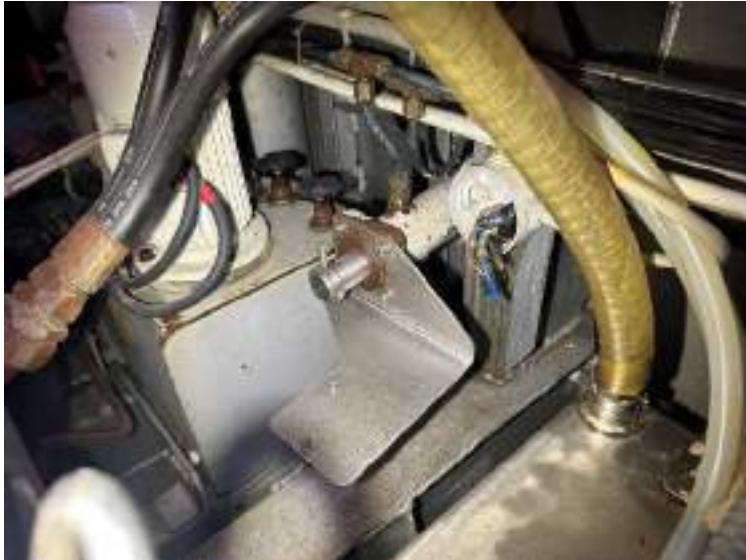
22 Starboard side of trim tab sensor was not in its place, missing.

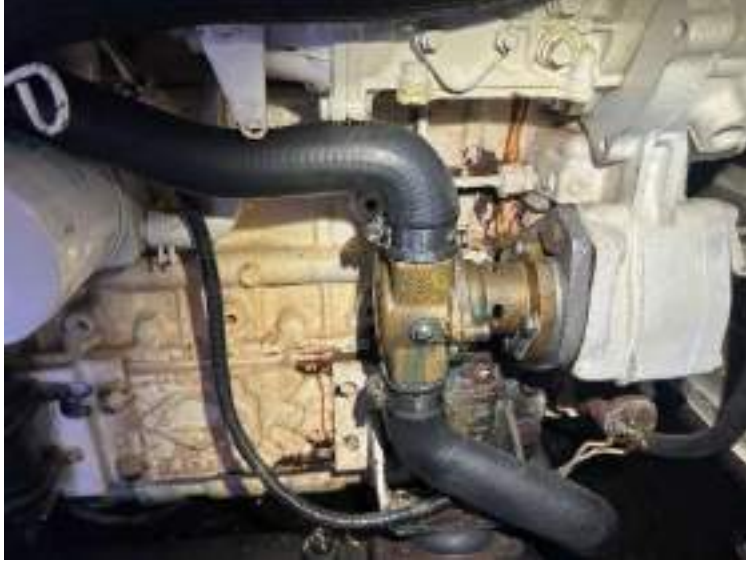
24

Port generator had too much corrosion on it.

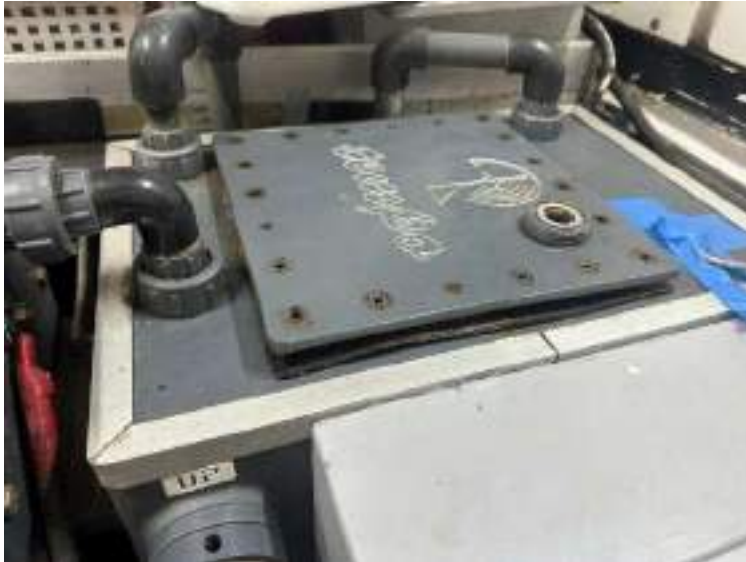
26

Black water treatment system sea water pump had crack and leak too much water.

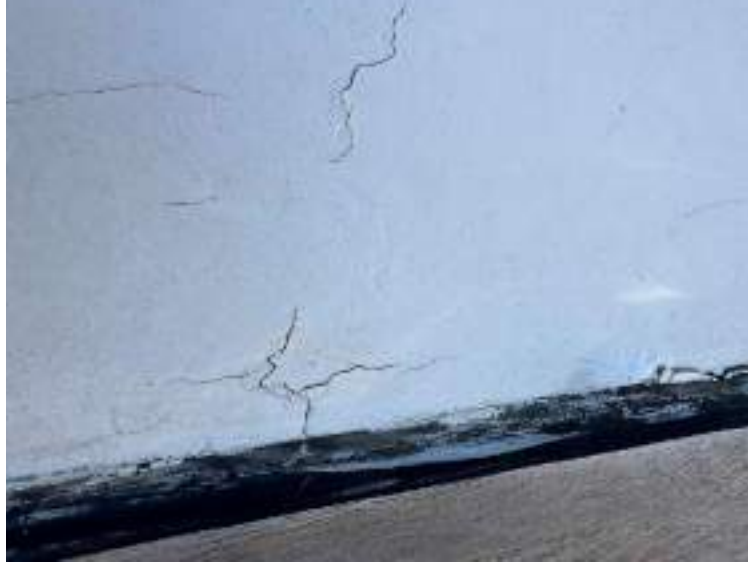
39

Side deck from inside was painted with non-proper white paint and surface was wavy. It was look like a wooden fishing boat. It had cracks and broken parts. The wood moisture levels were high for last five meters on bow side.

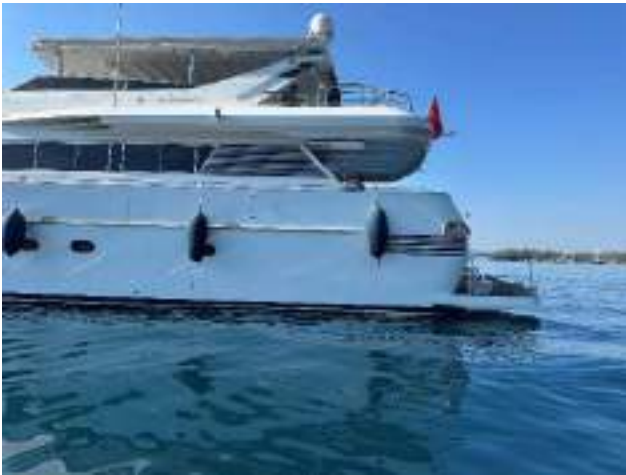
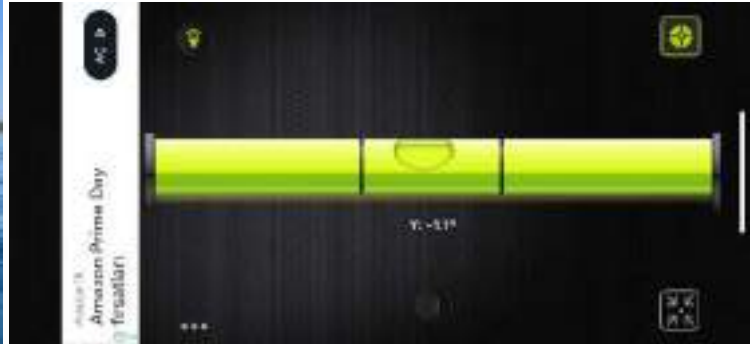
40

The boat heeled to the port side. We calculated thee points. The platform, aft cockpit and bow side. It was also seen by eye from outside. It was about 0.8 degree. The port aft side of the hull was below the antifouling level.

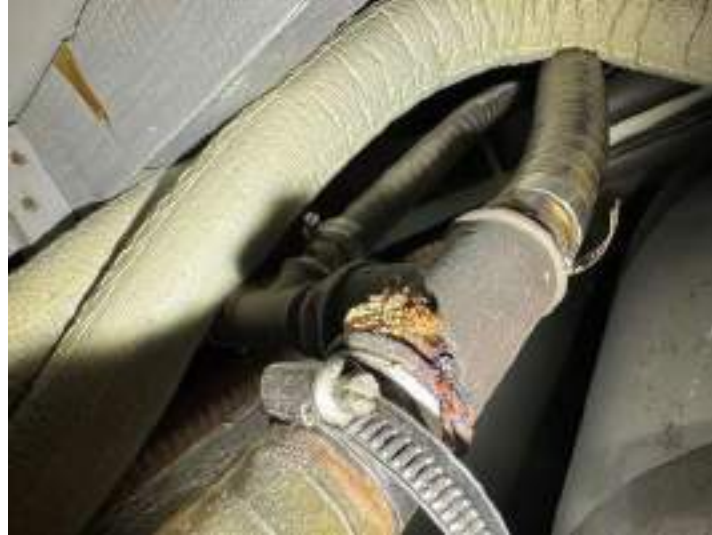
47

Corroded elbow was seen on the crew bilge.

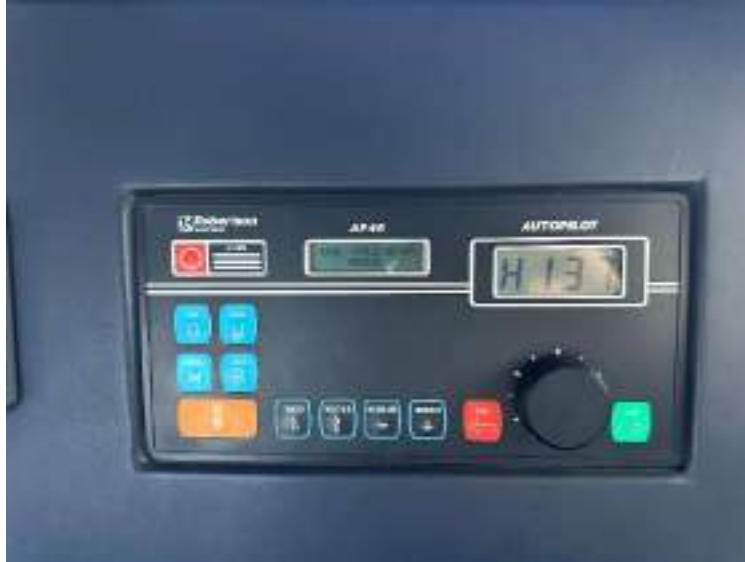
50

Autopilot didn't work.

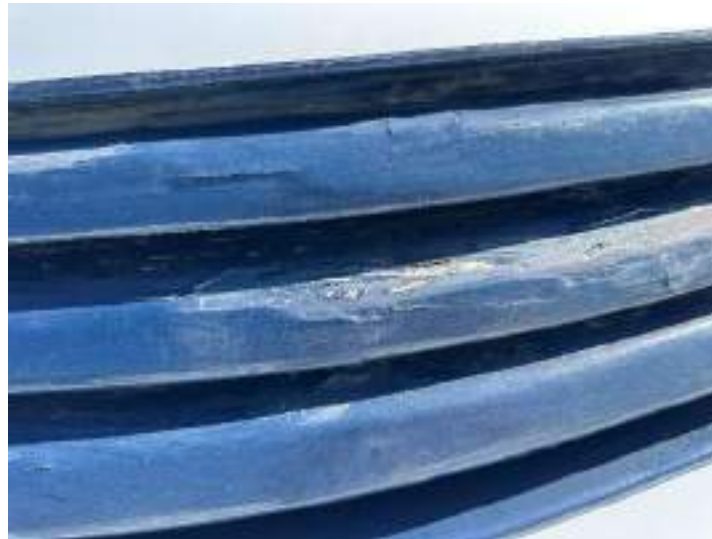
78

Dark Blue wooden parts of the foredeck staterd cracking. This part was painted with non-proper dark blue paint.
