Survey Report

03.08.2024

Portoroz Marina / Slovenia

Bavaria C46

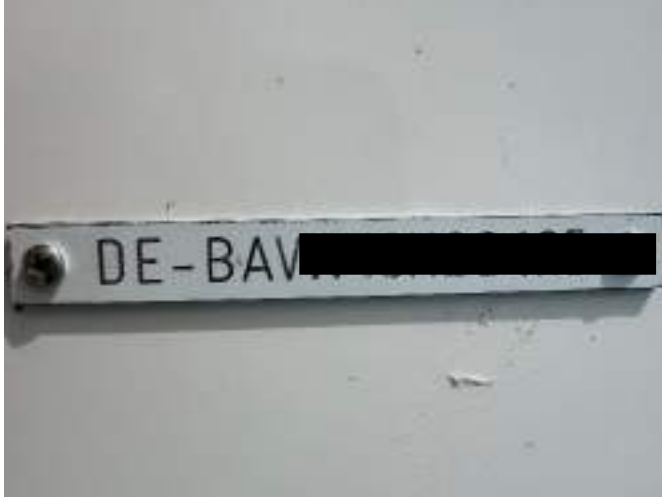
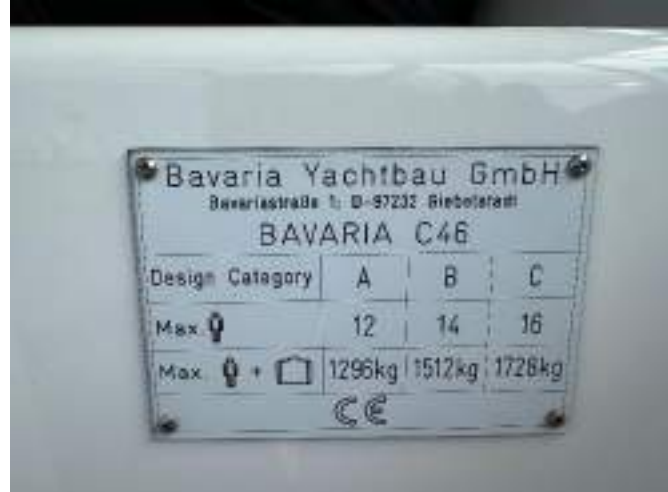
Original HIN(hull) number of boat was located starboard aft side of the boat. The boat started production on 2024 and model of 2025.

Builder certificate plate of boat was located in front of the starboard cockpit area. There is not any damage on it. This boat can navigate with 12 person in oceangoing A category.

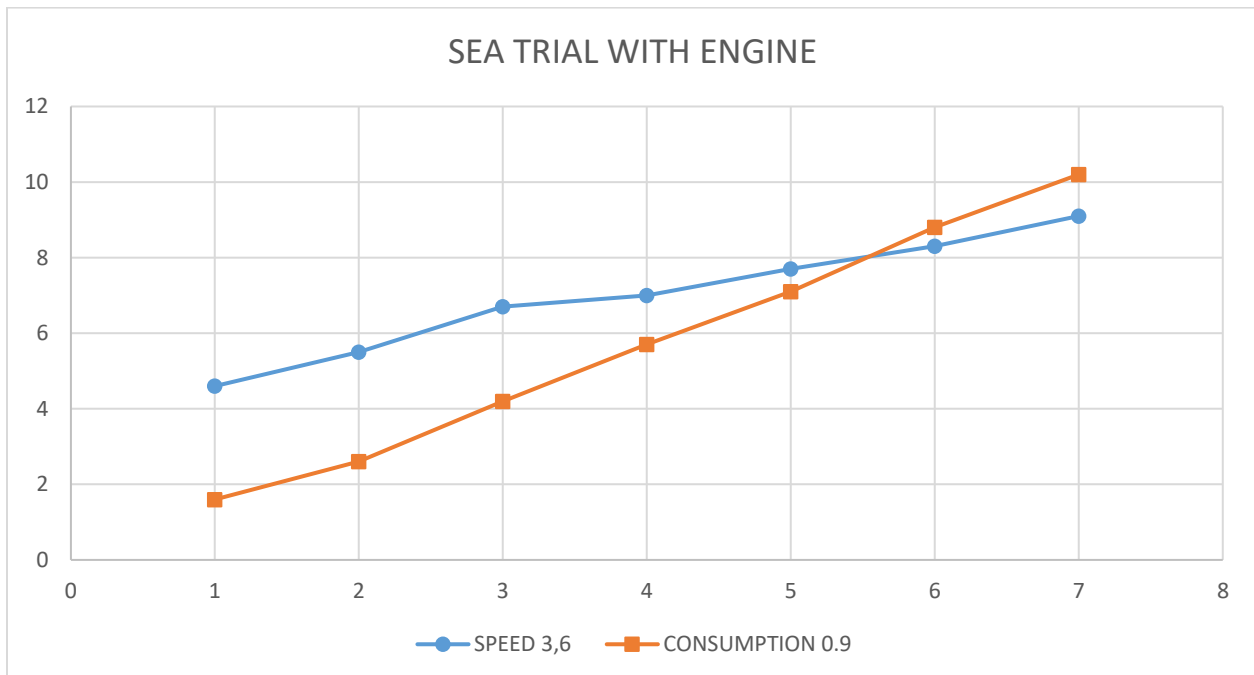
Remark 1: During sea trial, in higher rpm levels, different kind of sound and vibration was felt on cockpit. Vibration and strange friction noise was felt while moving the steering wheel after 2300 rpm. This was not normal for a sailboat.

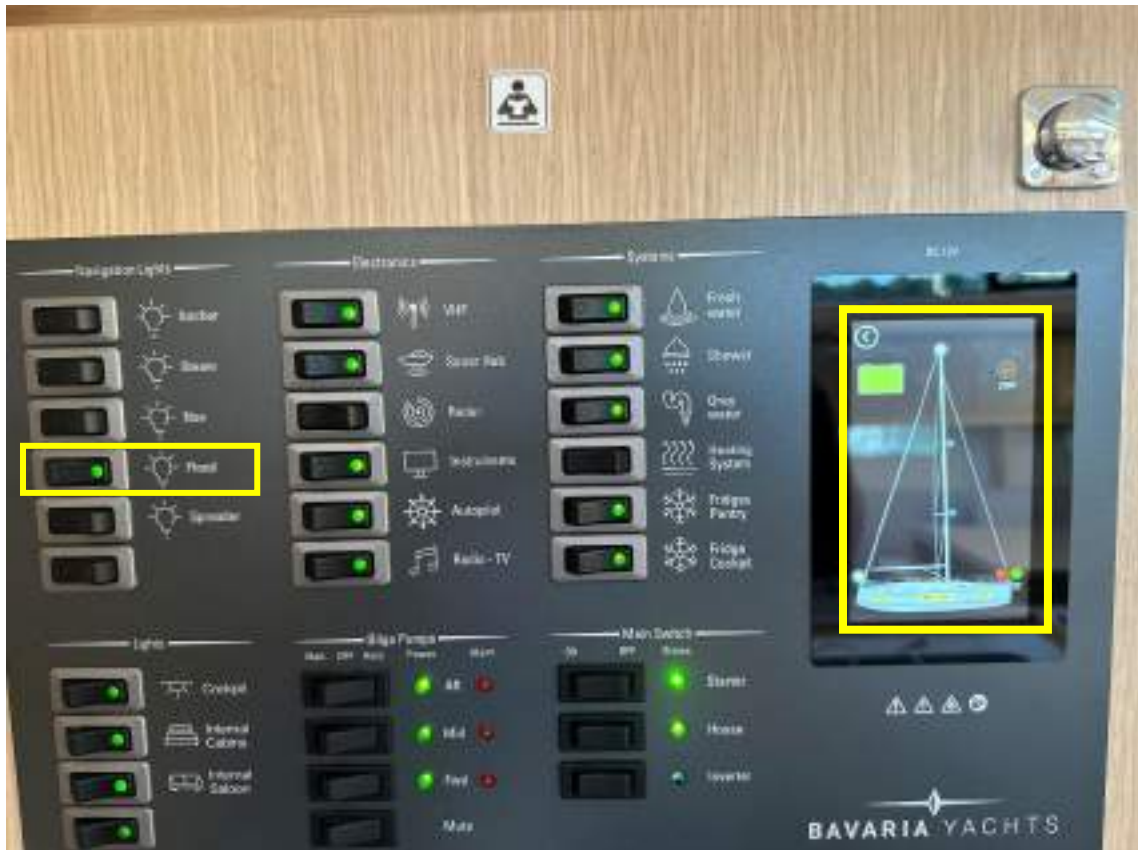
- **Remark 5:** Navigation lights buttons on electronic panel referred the wrong lights on panel boat graphic. If you open navigation light, it showed deck light open. Flood light button controls the navigation lights. Anchor light couldn't be closed.

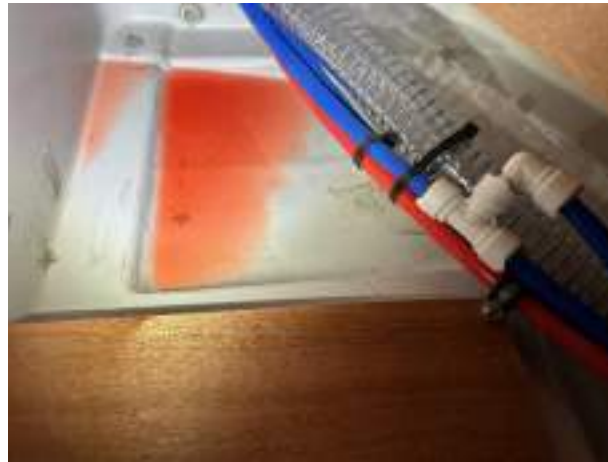
■ **Remark 7:** Too much pink coolant was seen on aft starboard bilge. The root cause couldn't be understood.

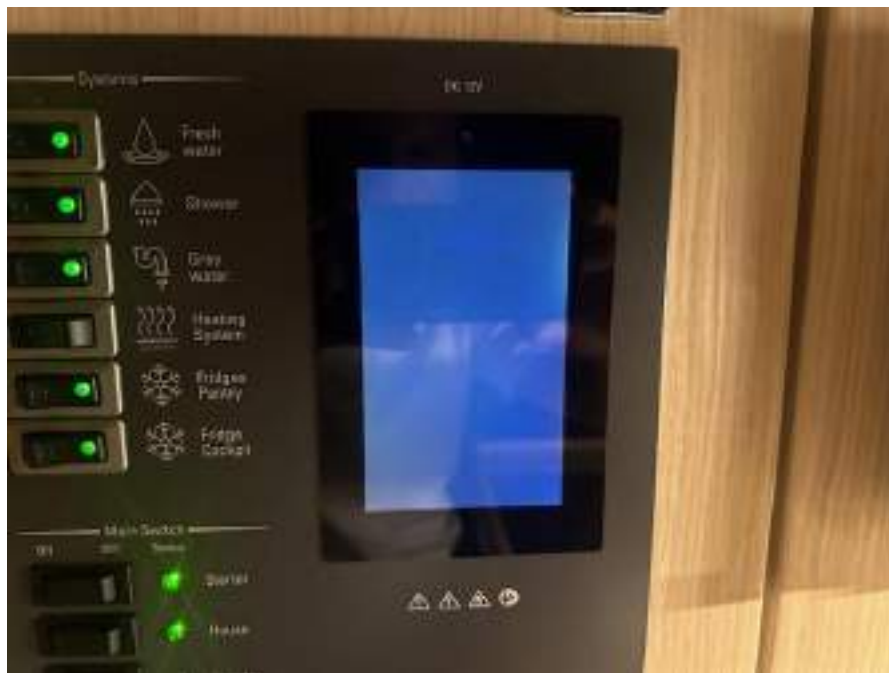
Salon electronic panel was broken before the sea trial to Türkiye. When we were sitting at night about 11:30 pm, we realised that the salon electronic display starts flipping and stop working.

07.08.2024 new saloon electronic panel was changed but the problem couldn't be solved totally.
