Survey Report

09.07.2025 – 10.07.2025

Yet Marina Göcek / Muğla

Admiral 27

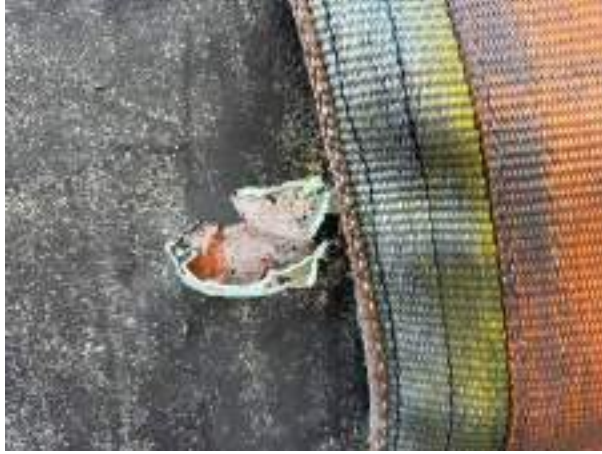
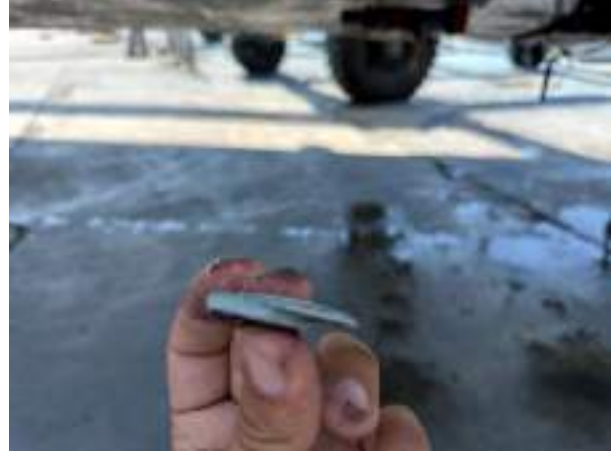
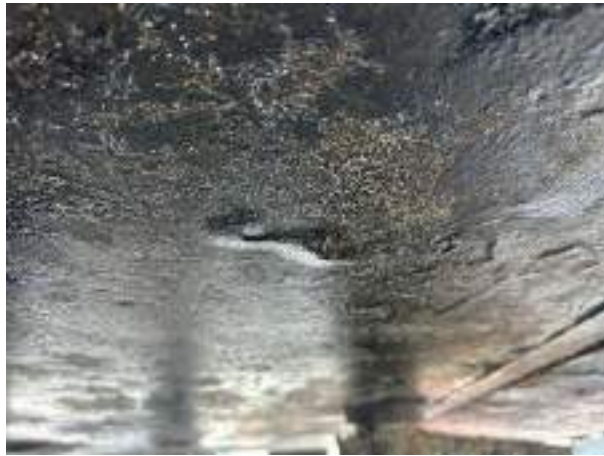
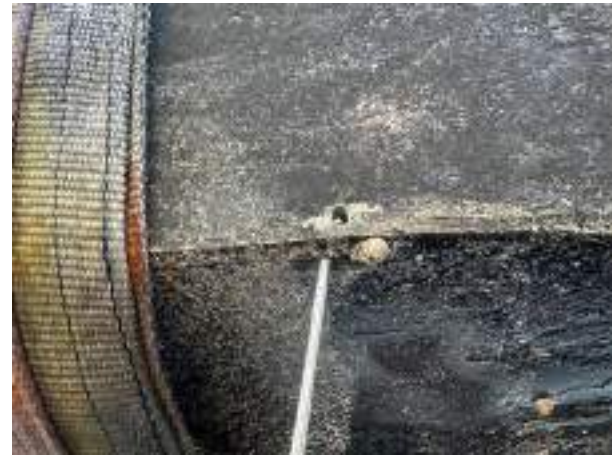
Many areas tick fillers had cracks and start removing from the aluminium hull. This size of filler couldn't stay longer on the aluminium hull.

You can check the tickness of filler used on the underwater hull from the below photos.

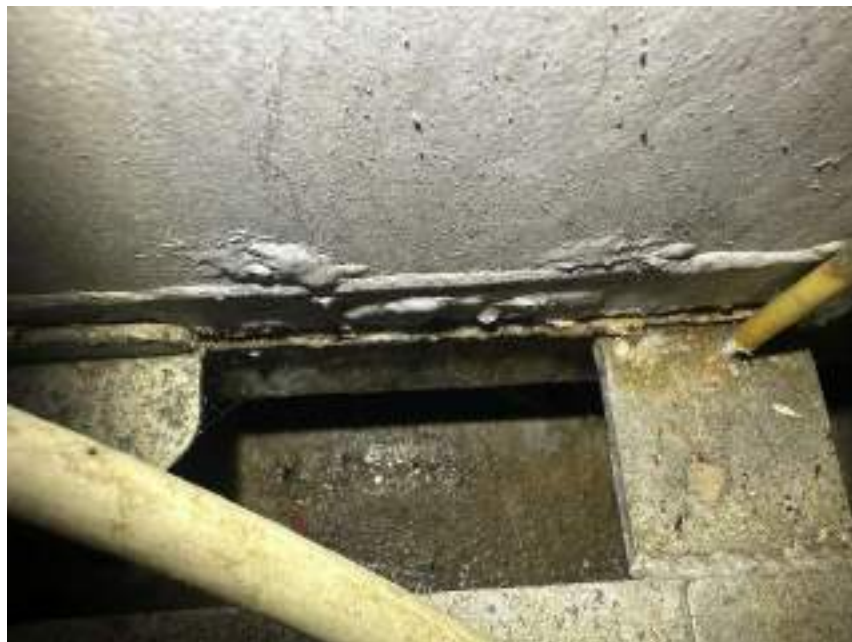
Fresh water system: It had two fresh water pump. One of the pump's brand was not seen. The boat had two fresh water pumps. One system was used with 24V DC voltage, the other pump was used with 220V AC voltage. The system had not any accumulator tank. Because of missing accumulator tank, the cabin's fresh water flow was changing and not strong enough. Fresh water tanks has paint detachments and some corrosion surfaces. It was not easy to repair the fresh water tanks without removing. Removing the tanks was not possible. All the equipments on the aft locker, like the generators must be removed. This was not easy.

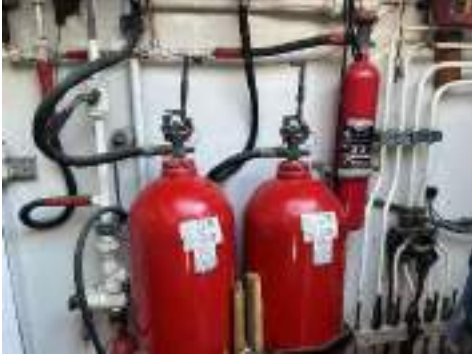
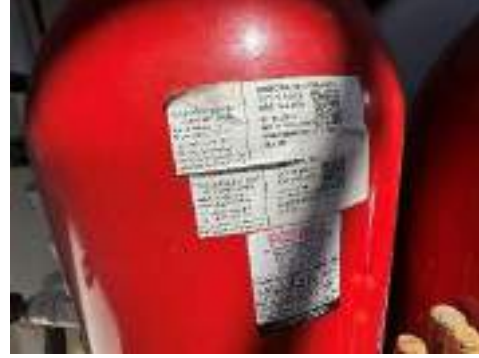
3

There was fire-system installed for the aft locker that was aft side of the engine room. It was not original and some of the fire system was changed by Turkish brand. The manufacture year was 2018. The maintenance of this fire system must be checked. The marin fire extinguishing system capacity was 50kg each. It had two fire extinguishers. There was not seen any pressure indicator of fire system. The system must be maintained, the next service day was passed.

Fire system maintenance must be done. The day was passed (aft locker)

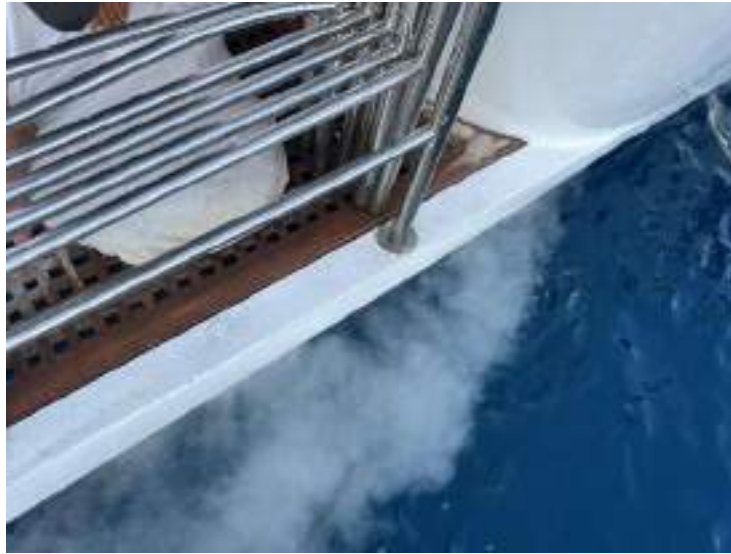
36

Starboard generator had white smoke while working. Sea water cooling system had problem.

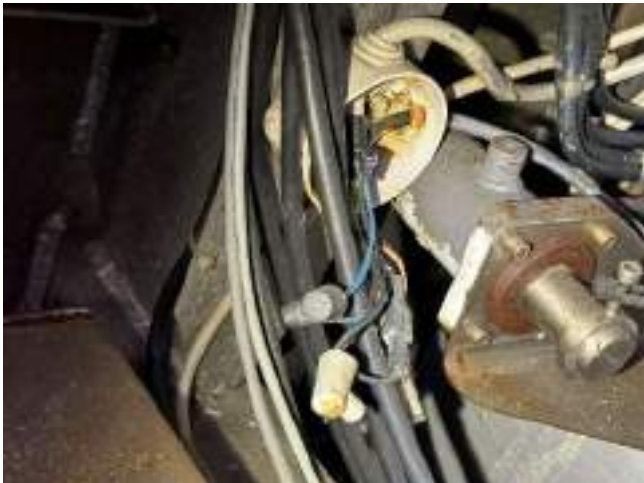
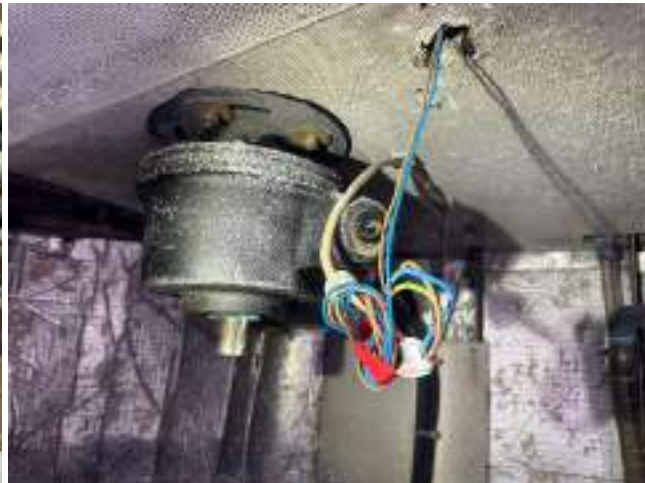
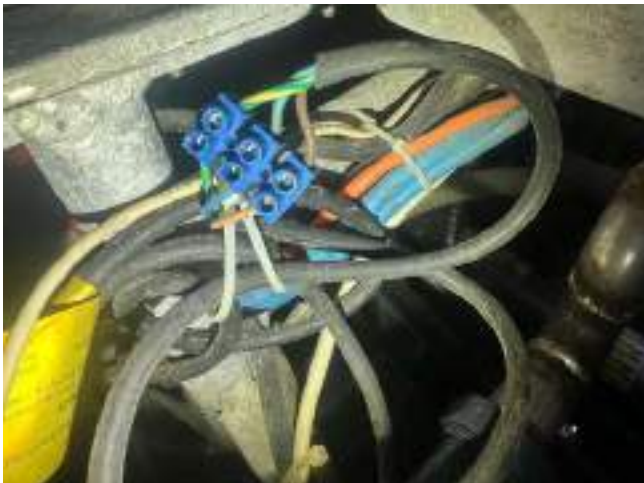
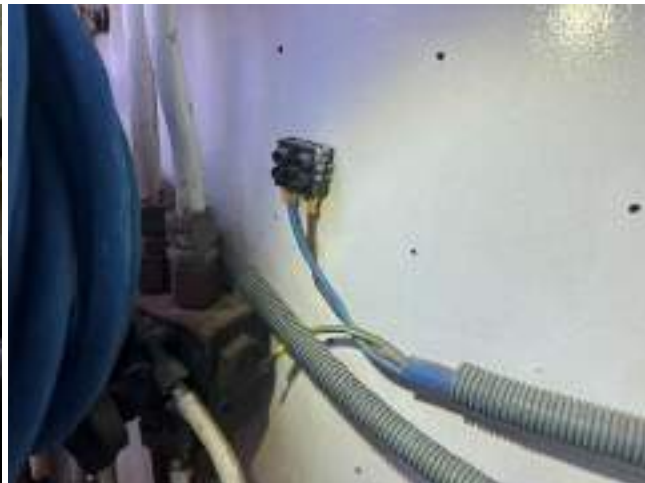
The boat had many cables that were not ending to somewhere. Some of them was cut, some of them was free. The boat's electric system was changed with a very unprofessional team. The boat's electric system was not safe.

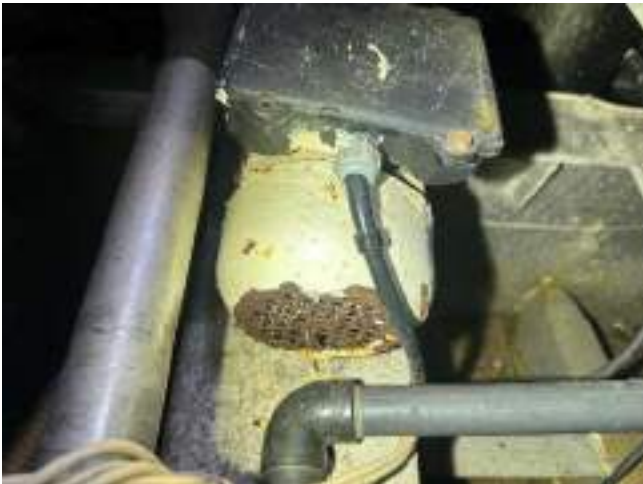
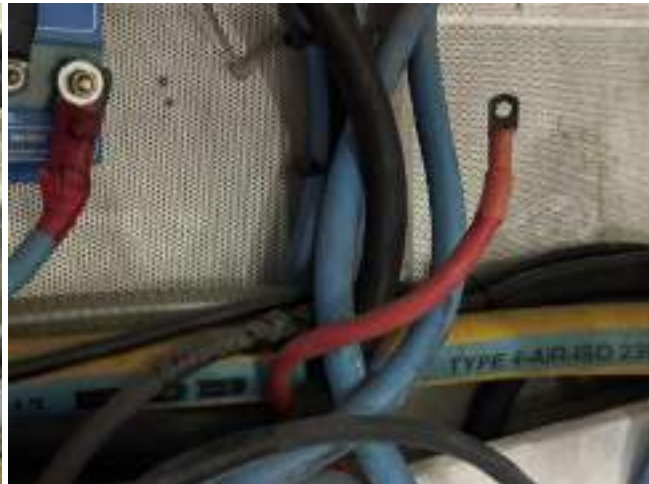
43

There was not connected red 10mm cable seen behind the engine batteries.

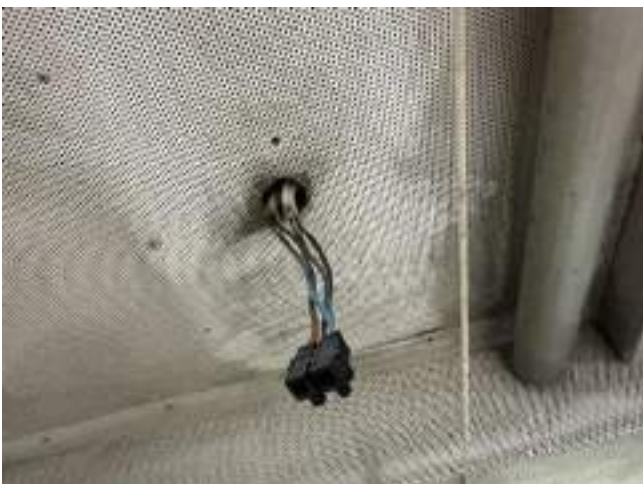
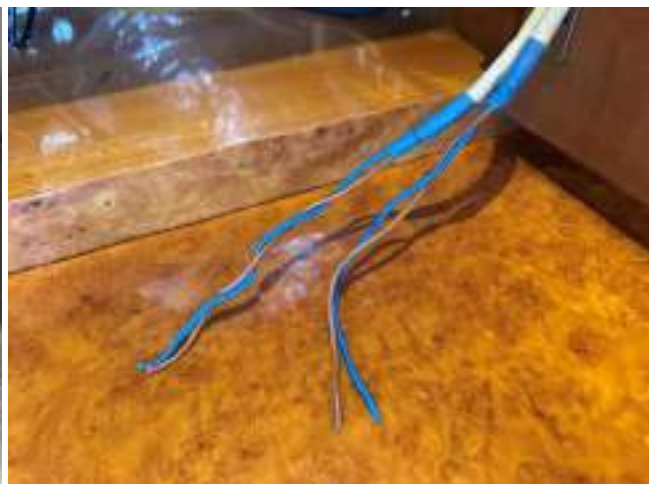
34

There was a not-safe electric socket on engine room for black water outlets.

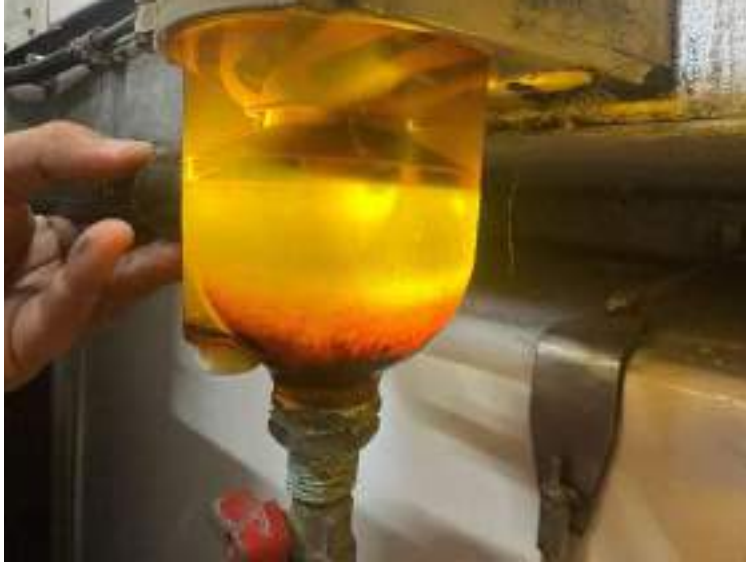
44	Engine Fuel separators was dirty.
62	Port generator fuel filter was very dirty.

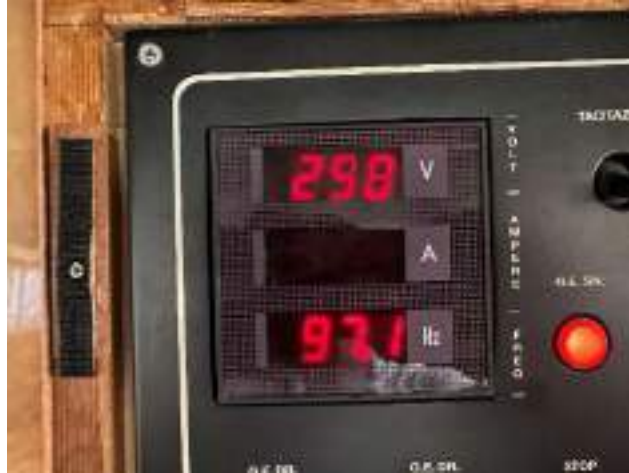
45	The voltage indicator of AC, shown in the captain room was not true. The voltage was about 280V and frequency was changing between 0 to 98hz.
----	---

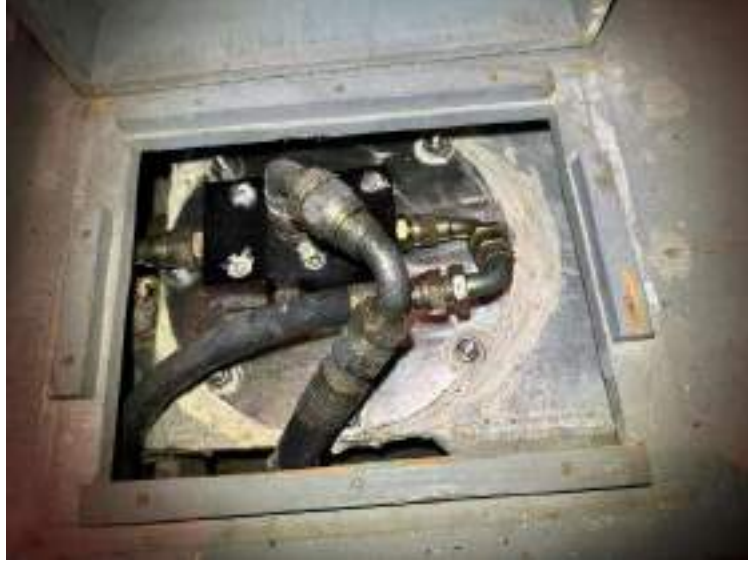
46

Bow thruster's hydraulic system under the crew area had not proper white sealing.

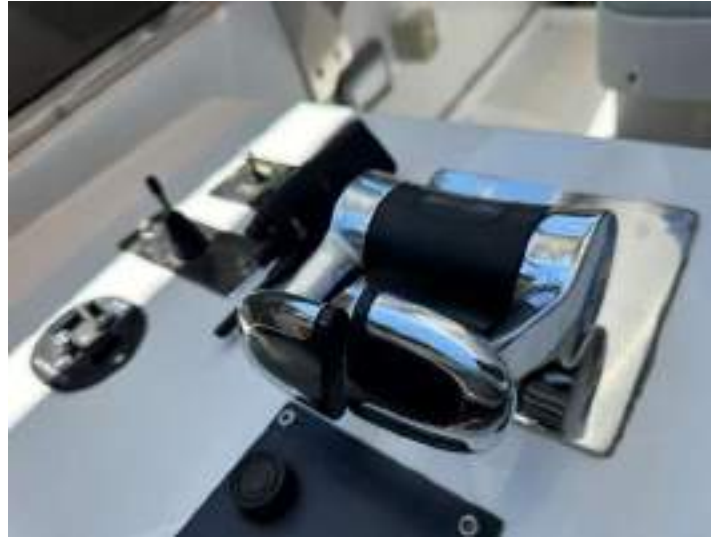
49

The ZF throttles were not calibrated.

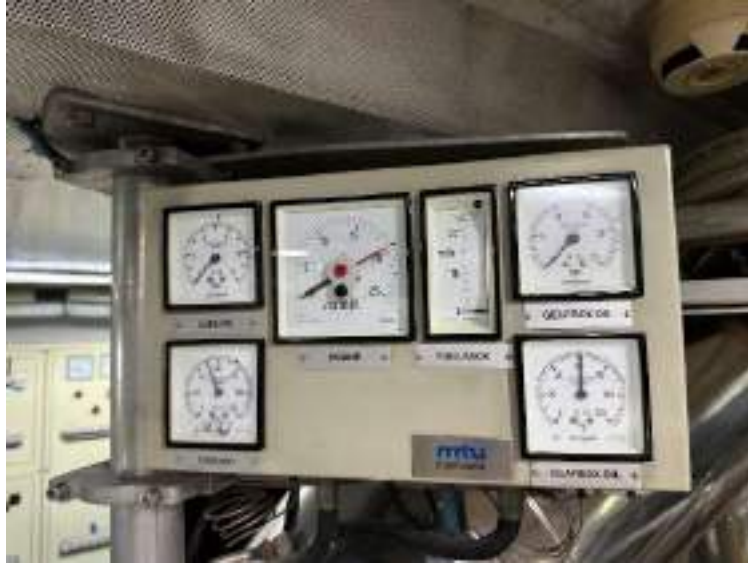
55

Port engines transmission oil and coolant temperature gauges in engine room showed different temperatures. We checked with thermal viewer. Transmission oil temperature showed 15C more. Port coolant temperature was below than standard.
